**Flood Control Project Maintenance  
Levee Inspections**

**Fall 2015 Levee Maintenance Deficiency Summary Report**

**Reclamation District No. 0551 Pearson**

**Levee Inspection Report By Mile - Fall 2015**

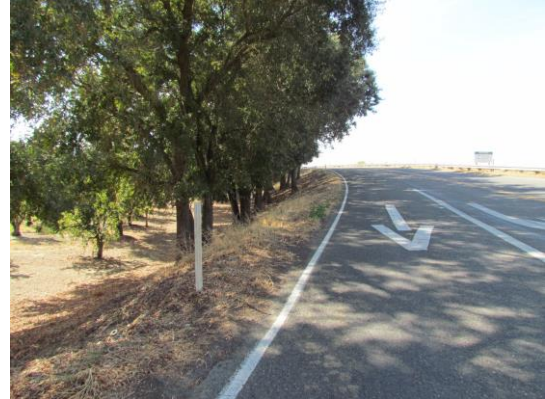
Photo 1 of 1 : FA\_2015\_RD0551\_175\_27\_20151019\_00018.jpg

Looking downstream from levee mile 0.00 to levee mile 6.78 all unwanted grasses has been removed from both the landside and waterside levee slopes.

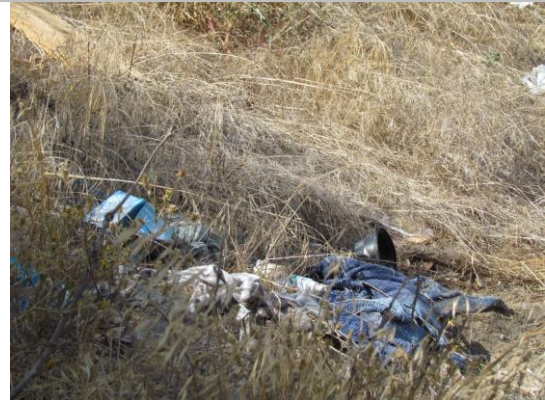
Photo 1 of 2 : FA\_2015\_RD0551\_175\_25\_20151019\_00016.jpg

LM Start	0.03	Rating **	M	Issue No.	25
LM End	0.03	Issue Type +	Ma	Location *	WS
Category	Earthen Levee			GPS Latitude/Longitude	
				Start	End
Item	Encroachments			38.336123 °	38.336123
				-121.565022 °	-121.565022
DWR ID	DWR_RD0551_01_f_2015_25				
Action/Comments					
Garbage Inspector Comments: Remove the garbage and mattress from the waterside slope.

RD 551 looking downstream from levee mile 0.02 garbage dumped on the waterside slope.

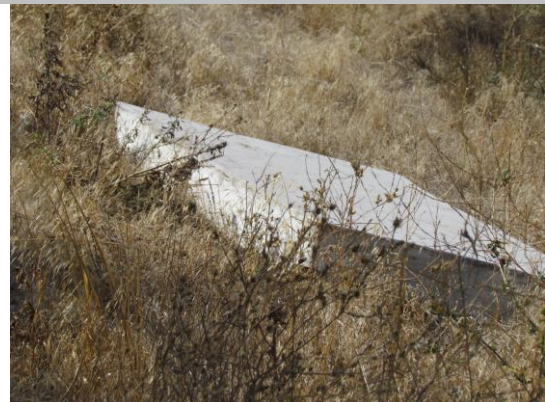
Photo 2 of 2 : FA\_2015\_RD0551\_175\_25\_20151019\_00017.jpg

Discarded mattress dumped on the waterside slope.

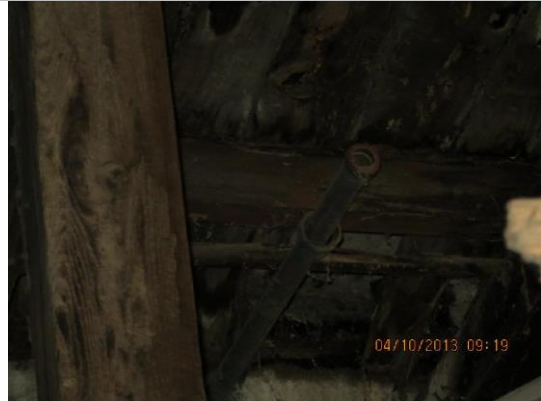
Photo 1 of 3 : UCIP\_FA\_2015\_0922.jpg

LM Start	0.41	Rating **	M	Issue No.	88
LM End	0.41	Issue Type +	En	Location *	WS
Category	Supplemental			GPS Latitude/Longitude	
				Start	End
Item	DWR UCIP Field Study			38.332039 °	38.332039 °
				-121.569730 °	-121.569730 °
DWR ID					
Action/Comments					
Inspector Comments: FS_ID:11705					
DS_ID:21982					
EP_NO: 2759					
FS_HLM: 0.412					
Repair Type: Non-Urgent					
Crossing Status: Found

Various disconnected pipes visible at foundation/retaining wall under buildings on LS.

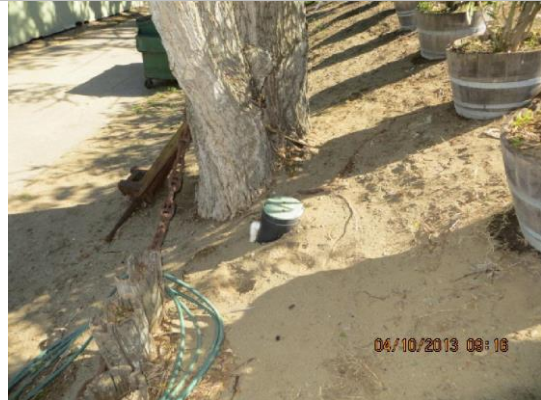
Photo 2 of 3 : UCIP\_FA\_2015\_0923.jpg

Irrigation pipes on WS slope.

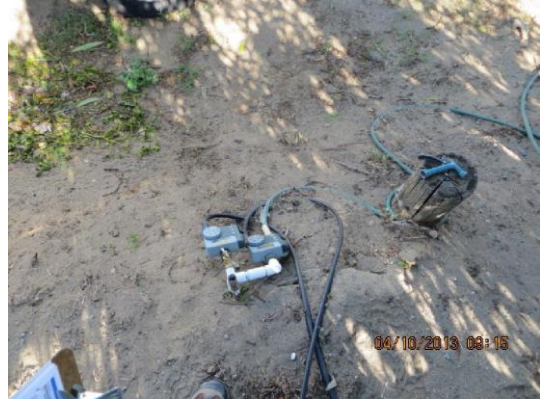
Photo 3 of 3 : UCIP\_FA\_2015\_0924.jpg

Irrigation pipes on WS slope.

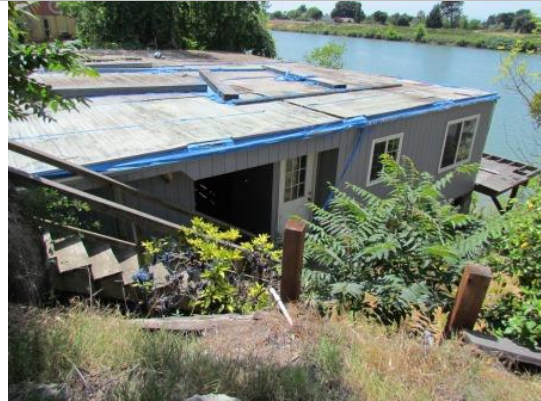
Photo 1 of 2 : FA\_2015\_RD0551\_175\_21\_20150915\_00001.jpg

Building and steps waterward. Photo taken 01-04-2014.

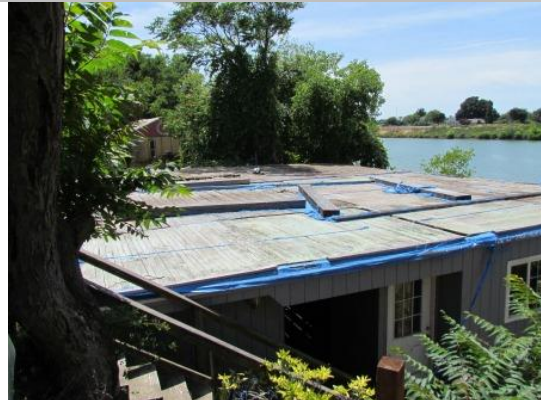
Photo 2 of 2 : FA\_2015\_RD0551\_175\_21\_20150915\_00002.jpg

Building remodeling project on waterside levee section. Photo taken 01-04-2014.

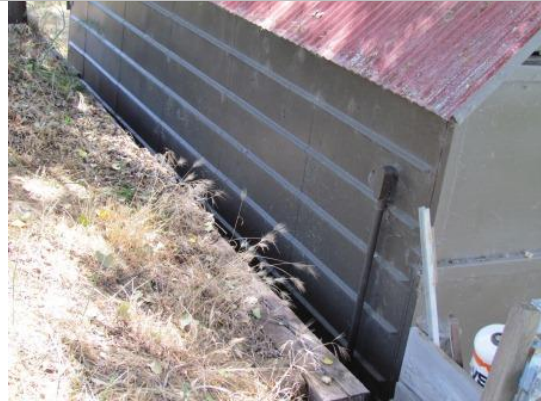
Photo 1 of 1 : FA\_2015\_RD0551\_175\_87\_20150915\_00003.jpg

This unauthorized retaining wall remains. Photo taken 01-04-2014. No photo taken during Fall 2014 inspection.

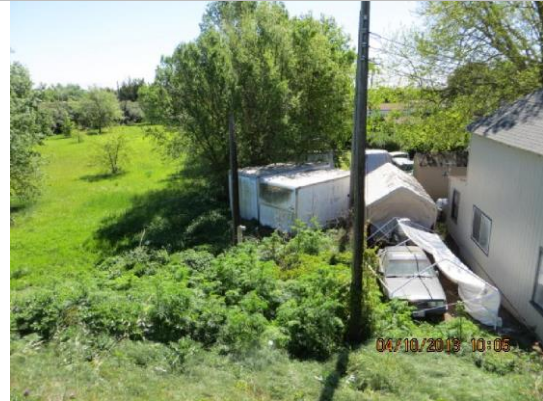
Photo 1 of 3 : UCIP\_FA\_2015\_0925.jpg

LM Start	0.71	Rating **	M	Issue No.	89
LM End	0.71	Issue Type +	En	Location *	WS
Category	Supplemental			GPS Latitude/Longitude	
				Start	End
Item	DWR UCIP Field Study			38.328401 °	38.328401 °
				-121.572954 °	-121.572954 °
DWR ID					
Action/Comments					
Inspector Comments: FS_ID:11726 DS_ID:21985 EP_NO: 6220 FS_HLM: 0.721 Repair Type: Non-Urgent Crossing Status: Found UCIP Comments: Pipe abandoned and should be removed. FIELD_STRUCT_DESC: 8-inch steel irrigation pipe through the levee 6.1-feet below the crown. Pump on waterside with slide gate and air vent. (Permit No. 6220, 1968) FS Date: 04/10/2013

JP and pipe covered with vegetation on LS toe.

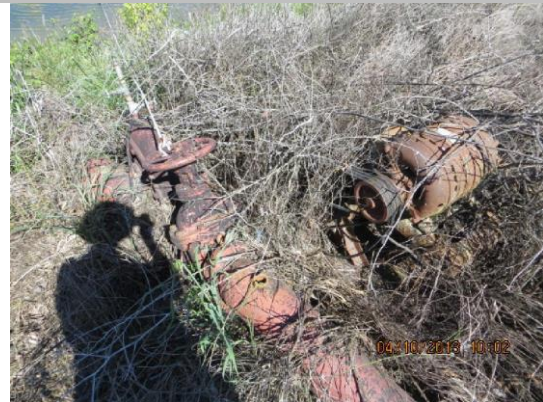
Photo 2 of 3 : UCIP\_FA\_2015\_0926.jpg

Pump, slide gate, and missing vent pipe on WS slope.

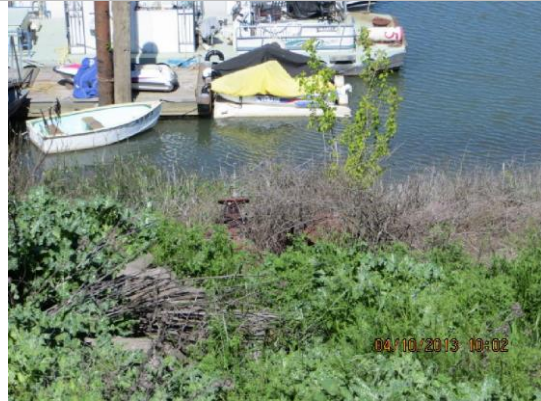
Photo 3 of 3 : UCIP\_FA\_2015\_0927.jpg

Abandoned pump covered in vegetation on WS slope.

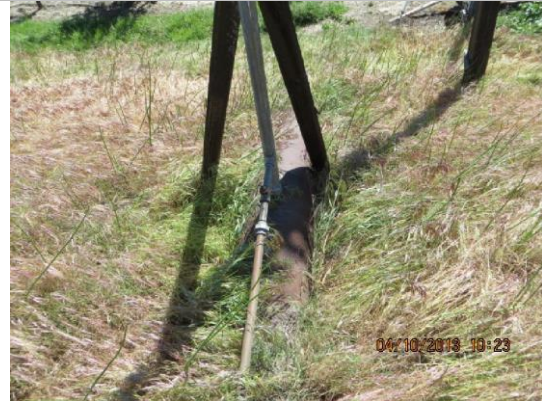
Photo 1 of 3 : UCIP\_FA\_2015\_0928.jpg

Inspector Comments: FS\_ID:11727  
 DS\_ID:21986  
 EP\_NO: 701  
 FS\_HLM: 0.903  
 Repair Type: Non-Urgent  
 Crossing Status: Found  
 UCIP Comments: Pipe appears abandoned and should be done so properly. Good candidate for video inspection.  
 FIELD\_STRUCT\_DESC: 14-inch steel irrigation pipe through the levee, 7.2 feet below crown. Pump in pump house on waterward slope. Service pole on landward slope. (Permit No. 701-Smith). 1-inch galvanized filler pipe and a 2-inch electrical conduit at same location. Originally included in O+M manual (1959).  
 FS Date: 04/10/2013

galvanized iron filler pipe and 16-inch pipe visible at LS toe.

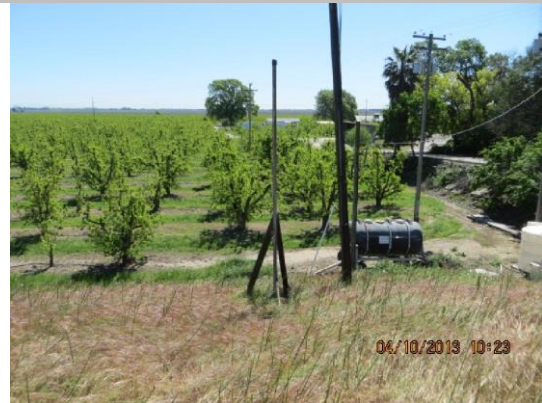
Photo 2 of 3 : UCIP\_FA\_2015\_0929.jpg

Pipe and JP visible on LS toe.

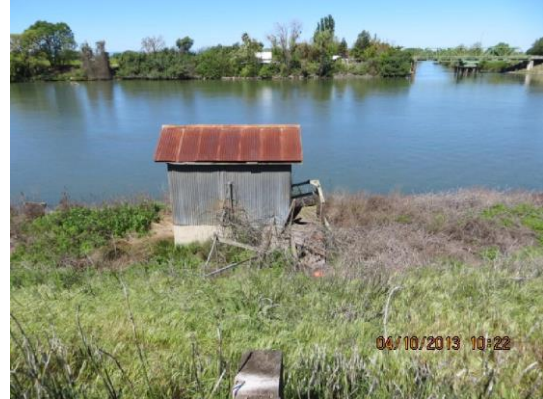
Photo 3 of 3 : UCIP\_FA\_2015\_0930.jpg

Pump house and pipes visible on WS slope.

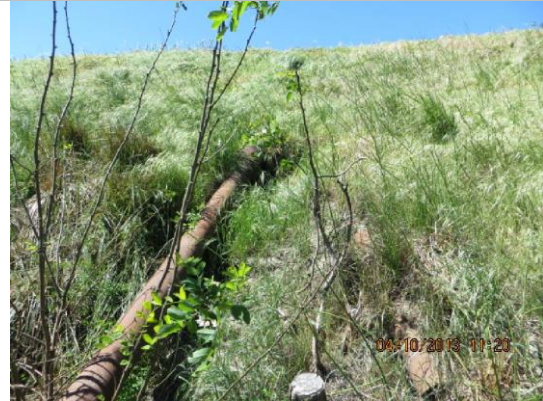
Photo 1 of 3 : UCIP\_FA\_2015\_2600.jpg

Action/Comments					
Inspector Comments: FS_ID:26874 DS_ID:21990 EP_NO: 11145 FS_HLM: 1.792 Repair Type: Non-Urgent Crossing Status: Found UCIP Comments: Based on District notes from January 14, 2014, pump discharge pipe has been repaired. Pipe failing on LS slope causing erosion along pipe alignment. Pipe debris on both slopes should be removed as well.: As of 12/13/2013 District President noted that the landowner had made repairs to the LS slope leaks.: As of 12/17/2013 District submitted letter to landowner explaining UCIP report details including photos of the pipe problems FIELD_STRUCT_DESC: 10-inch pipe through levee, 4.7 feet below crown. Pump in 7'X9' concrete pump house on waterward slope. 36-inch concrete riser on LS toe. 1-inch electrical conduit at same location. Service pole at landward toe (ABO No. 11145-Towne). Originally included in O+M manual (1959). FS Date: 01/15/2014

Pipe failing on LS slope due to corrosion holes causing erosion.

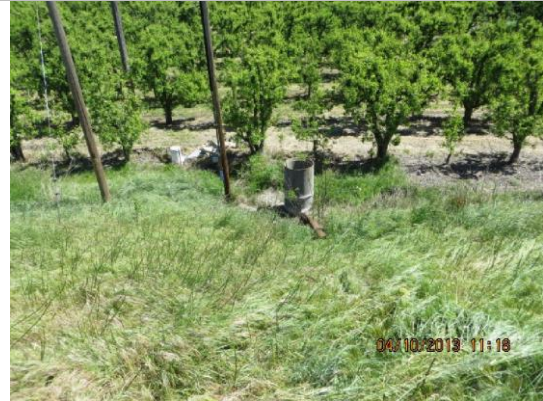
Photo 2 of 3 : UCIP\_FA\_2015\_2601.jpg

36-inch concrete standpipe at LS toe.

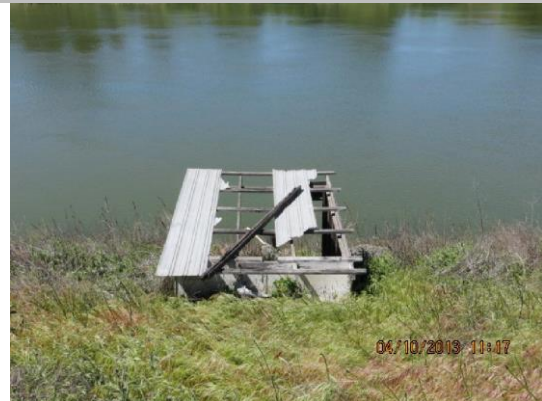
Photo 3 of 3 : UCIP\_FA\_2015\_2602.jpg

Pumphouse on WS slope.

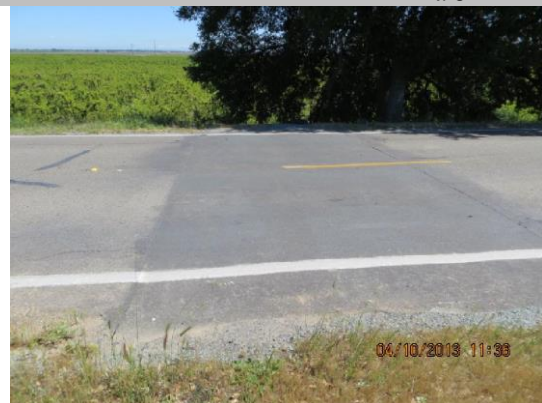
Photo 1 of 1 : UCIP\_FA\_2015\_0748.jpg

LM Start	2.01	Rating **	M	Issue No.	92
LM End	2.01	Issue Type +	En	Location *	LS
Category	Supplemental			GPS Latitude/Longitude	
				Start	End
Item	DWR UCIP Field Study			38.310237 °	38.310237 °
				-121.575470 °	-121.575470 °
DWR ID					
Action/Comments					
Inspector Comments: FS_ID:11749					
DS_ID:22040					
EP_NO: 3676					
FS_HLM: 2.033					
Repair Type: Non-Urgent					
Crossing Status: Not Found					
UCIP Comments: Fresh cut through pavement on crown indicates recent work on pipes at this location. Need to determine if pipe was removed or abandoned in place.					
FIELD_STRUCT_DESC: 2 of 2: 8-inch steel irrigation pipe sleeved through a 12-inch pipe, 5 feet below crown. Pump on platform waterside. (Permit No. 3676-Wheeler).					
FS Date: 04/10/2013

Fresh cut through pavement at crown.

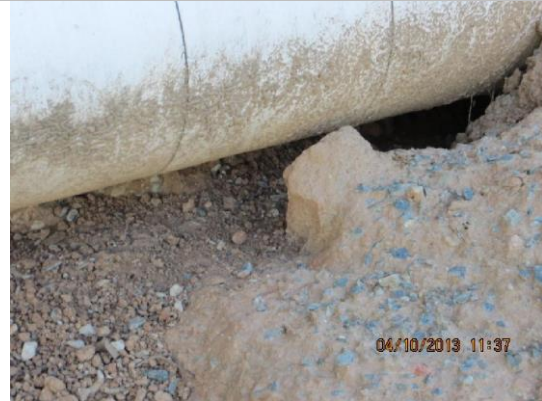
Photo 1 of 3 : UCIP\_FA\_2015\_0749.jpg

Action/Comments					
Inspector Comments: FS_ID:11763 DS_ID:21991 EP_NO: 6551 FS_HLM: 2.034 Repair Type: Non-Urgent Crossing Status: Found UCIP Comments: Rodent activity undermining pipe on LS slope. FIELD_STRUCT_DESC: 1 of 2: 14-inch PVC wrapped Steel irrigation pipe 3-feet below the crown. Butterfly valve on WS shoulder. 2-inch galvanized electric conduit at same location. Pump on pile structure on WS toe. Pressure booster and pump on LS toe. (Permit No. 6551-Wheeler 1969). FS Date: 04/10/2013

Rodent activity undermining pipe on LS slope.

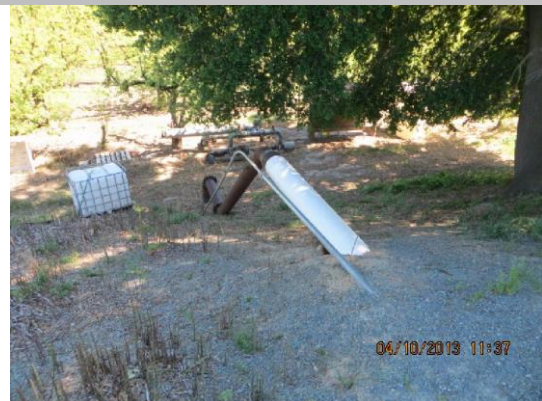
Photo 2 of 3 : UCIP\_FA\_2015\_0750.jpg

Pipe, electrical conduit, and booster pump on LS toe.

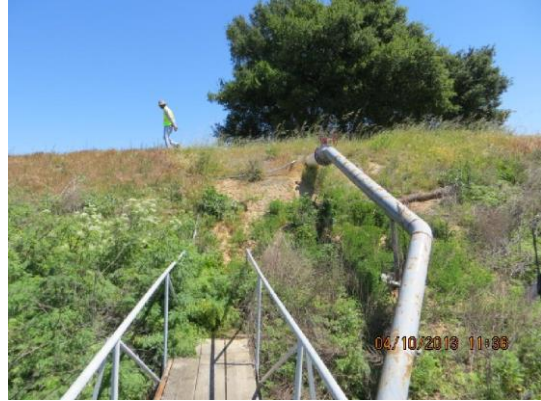
Photo 3 of 3 : UCIP\_FA\_2015\_0751.jpg

Pipe, butterfly valve, and electrical conduit 3-feet below the crown on the WS shoulder.

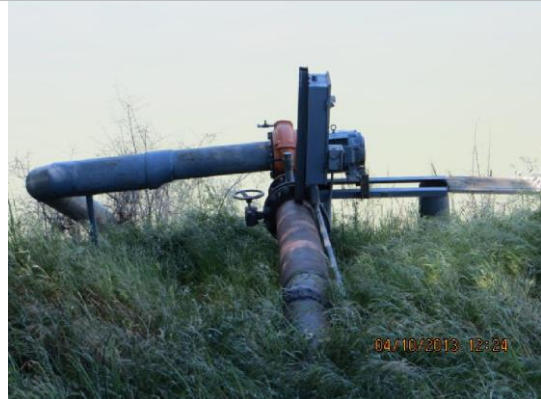
Photo 1 of 2 : UCIP\_FA\_2015\_0752.jpg

LM Start	2.41	Rating **	M	Issue No.	94
LM End	2.41	Issue Type +	En	Location *	LS
Category	Supplemental			GPS Latitude/Longitude	
				Start	End
Item	DWR UCIP Field Study			38.305189 °	38.305189 °
				-121.572012 °	-121.572012 °
DWR ID					
Action/Comments					
Inspector Comments: FS_ID:11783 DS_ID:21994 EP_NO: 11141 FS_HLM: 2.433 Repair Type: Non-Urgent Crossing Status: Found UCIP Comments: Records indicate this pipe was abandoned, but it appears to be active. Verify status. FIELD_STRUCT_DESC: 10-inch steel irrigation pipe through levee, 8.0 feet below the crown. Slant pump on waterward slope. Service pole on landward slope with a 1.5-inch galvanized iron electrical conduit through the levee at same location. (ABO No. 11141-Runyon). Originally included in O+M manual (1959). FS Date: 04/10/2013

Pump, pipe, and butterfly valve on WS slope.

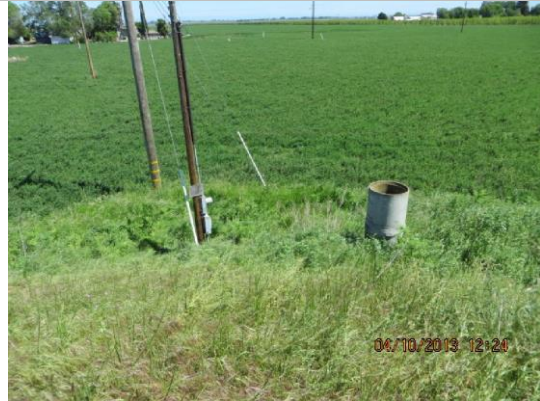
Photo 2 of 2 : UCIP\_FA\_2015\_0753.jpg

JP and concrete standpipe on LS toe.

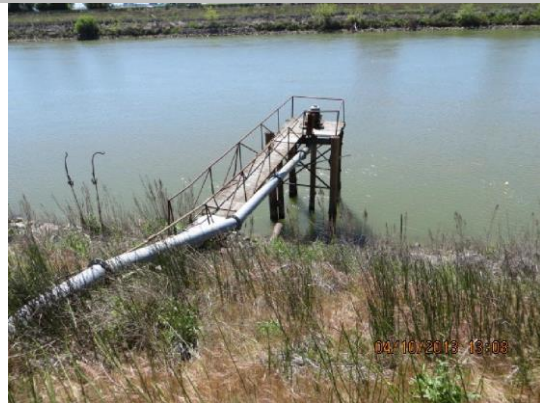
Photo 1 of 2 : UCIP\_FA\_2015\_0767.jpg

LM Start	2.96	Rating **	M	Issue No.	95
LM End	2.96	Issue Type +	En	Location *	LS
Category	Supplemental			GPS Latitude/Longitude	
				Start	End
Item	DWR UCIP Field Study			38.298323 °	38.298323 °
				-121.566941 °	-121.566941 °
DWR ID					
Action/Comments					
Inspector Comments: FS_ID:11803 DS_ID:22032 EP_NO: 1204 FS_HLM: 2.987 Repair Type: Non-Urgent Crossing Status: Found UCIP Comments: Gap between sleeved pipes does not appear to be grouted on LS slope. FIELD_STRUCT_DESC: 12-inch steel conduit with 10-inch irrigation pipe sleeved through it 6-feet below the crown. Pump on pile structure on the Water Side toe. 48-inch concrete riser on LS toe. (Permit No. 1204-Wheeler). Originally included in the O+M manual 1959. FS Date: 04/10/2013

10-inch steel irrigation pipe and steel pump structure on WS toe.

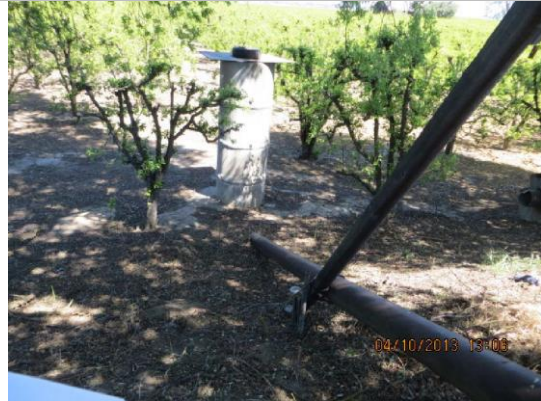
Photo 2 of 2 : UCIP\_FA\_2015\_0768.jpg

48-inch concrete riser on LS toe.

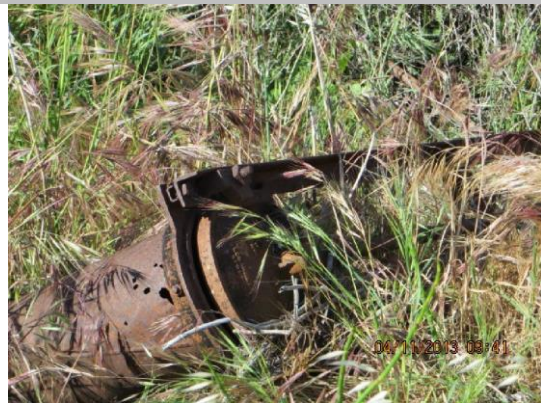
Photo 1 of 2 : UCIP\_FA\_2015\_0821.jpg

LM Start	4.01	Rating **	M	Issue No.	96
LM End	4.01	Issue Type +	En	Location *	LS
Category	Supplemental			GPS Latitude/Longitude	
				Start	End
Item	DWR UCIP Field Study			38.286593 °	38.286593 °
				-121.554591 °	-121.554591 °
DWR ID					
Action/Comments					
Inspector Comments: FS_ID:11817 DS_ID:22034 EP_NO: N/A FS_HLM: 4.05 Repair Type: Non-Urgent Crossing Status: Found UCIP Comments: Abandoned. Determine if pipe was removed or abandoned in place. FIELD_STRUCT_DESC: 8-inch irrigation pipe through the levee 6.7-feet below the crown. Abandoned slide gate at pad on WS slope. Originally included in O+M manual 1959. FS Date: 04/11/2013

Abandoned slide gate on WS slope.

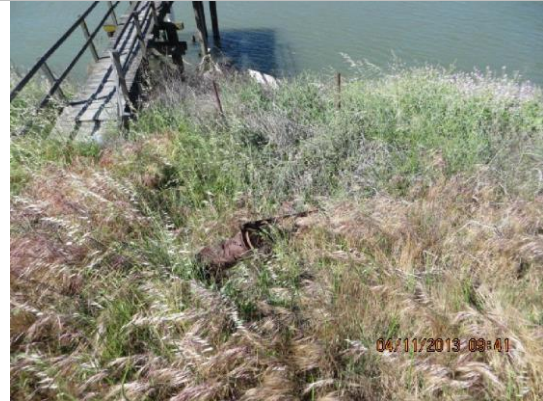
Photo 2 of 2 : UCIP\_FA\_2015\_0822.jpg

Abandoned slide gate on WS slope.

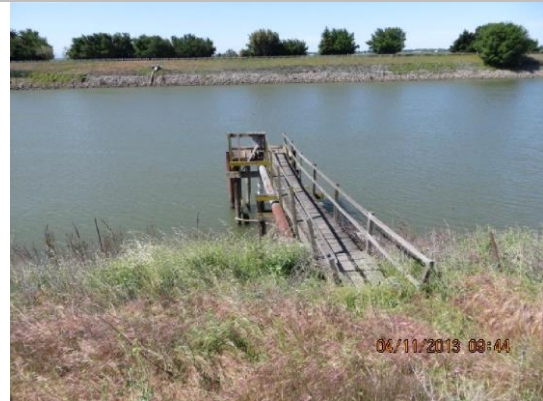
Photo 1 of 2 : UCIP\_FA\_2015\_0823.jpg

Pump on pier with wooden walkway on WS toe.

Inspector Comments: FS\_ID:11823  
DS\_ID:22018  
EP\_NO: 11146  
FS\_HLM: 4.052  
Repair Type: Non-Urgent  
Crossing Status: Found  
UCIP Comments: Wooden walkway in bad repair and presents a hazard to the public.  
FIELD\_STRUCT\_DESC: 14-inch pipe through levee, 10.4 feet below crown. Pump on pile structure in stream with wooden walkway. 48-inch concrete standpipe on LS toe with booster pump and electric panel. Siphon breaker in 24-inch CMP riser on LS slope. 1.5-inch electrical conduit at same location.(ABO No. 11146- Turner). Originally included in O+M manual 1959.  
FS Date: 04/11/2013

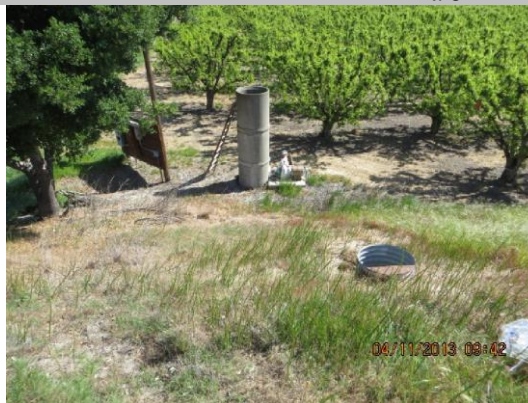
Photo 2 of 2 : UCIP\_FA\_2015\_0824.jpg

24-inch CMP riser and 48-inch concrete riser on LS slope.

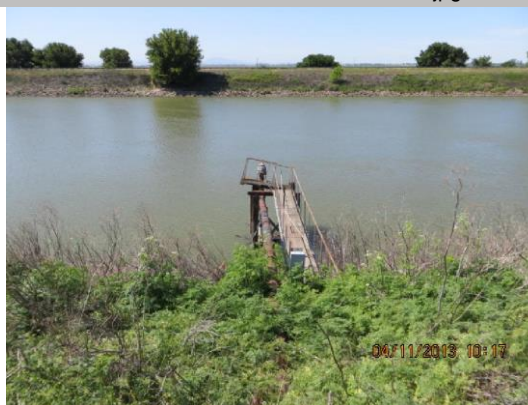
Photo 1 of 2 : UCIP\_FA\_2015\_2640.jpg

Inspector Comments: FS\_ID:46644  
DS\_ID:22020  
EP\_NO: 11152  
FS\_HLM: 4.634  
Repair Type: Urgent  
Crossing Status: Found  
UCIP Comments: Pier for pump is falling apart and is a hazard to the public. Some settlement along pipe on LS slope.: As of 12/13/2013 the District has contacted the tenant farmer who is in the process of contacting the owner to update on condition of pipe: As of 12/17/2013 District submitted letter to landowner explaining UCIP report details including photos of the pipe problems: (Olivia) As of 09/21/2015 owner is working with Gilbert Labrie, LMA consultant, to resolve issue.  
FIELD\_STRUCT\_DESC: 10-inch steel irrigation pipe through the levee 6.5 feet below the crown. Pump on pile structure in stream. Service pole at landward toe and a 36-inch concrete riser on the LS toe. 1-inch electrical conduit at same location. (ABO No. 11152-Wilcox) Originally included in O+M manual 1959.

Pump on pier showing structural failure on WS toe.

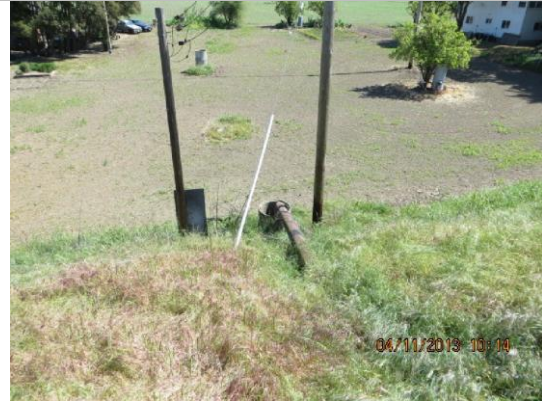
Photo 2 of 2 : UCIP\_FA\_2015\_2641.jpg

Pipe and stand pipe on LS toe with subsidence along pipe on LS slope.

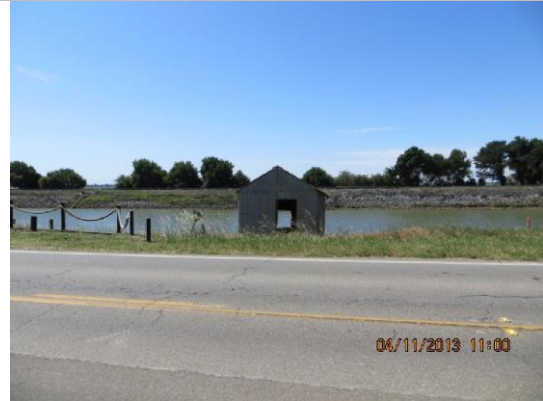
Photo 1 of 3 : UCIP\_FA\_2015\_0836.jpg

LM Start	5.05	Rating **	M	Issue No.	99
LM End	5.05	Issue Type +	En	Location *	LS
Category	Supplemental			GPS Latitude/Longitude	
				Start	End
Item	DWR UCIP Field Study			38.276220 °	38.276220 °
				-121.540811 °	-121.540811 °
DWR ID					
Action/Comments					
Inspector Comments: FS_ID:12105 DS_ID:22022 EP_NO: 11125 FS_HLM: 5.1 Repair Type: Non-Urgent Crossing Status: Found UCIP Comments: Pumphouse has been removed from pump and pump is in disrepair. Pipe at LS toe is sleeved or has been replaced with a 6-inch PVC pipe. This pump appears abandoned and should be done so properly. FIELD_STRUCT_DESC: 6-inch pipe through the levee 6.5-feet below the crown. Pump and slide gate on WS slope. 1-inch electrical conduit at same location with service pole at landward toe. 4'X6' concrete distribution box at LS toe (ABO No. 11125- Cortopassi). Originally included in O+M manual 1959. FS Date: 04/11/2013

Relocated pumphouse on WS shoulder.

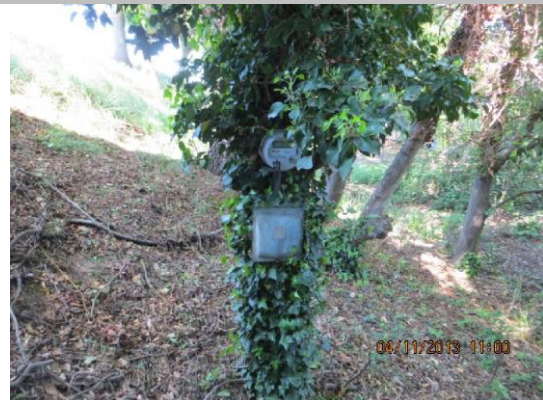
Photo 2 of 3 : UCIP\_FA\_2015\_0837.jpg

Meter on pole at LS toe.

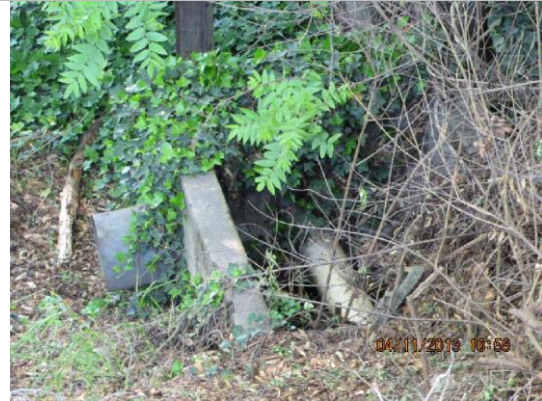
Photo 3 of 3 : UCIP\_FA\_2015\_0838.jpg

Pipe in distribution box at LS toe.

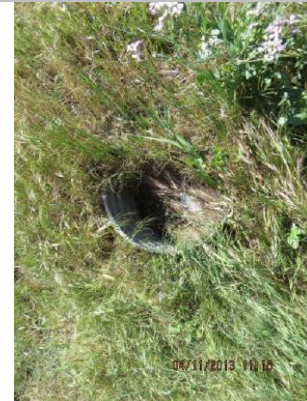
Photo 1 of 3 : UCIP\_FA\_2015\_2603.jpg

LM Start	5.26	Rating **	M	Issue No.	100
LM End	5.26	Issue Type +	En	Location *	LS
Category	Supplemental			GPS Latitude/Longitude	
				Start	End
Item	DWR UCIP Field Study			38.274147 °	38.274147 °
				-121.538076 °	-121.538076 °
DWR ID					
Action/Comments					
Inspector Comments: FS_ID:26875 DS_ID:22023 EP_NO: 11131 FS_HLM: 5.307 Repair Type: Non-Urgent Crossing Status: Found UCIP Comments: Based on District notes from January 15, 2014, pump discharge pipe has been repaired. Corrosion holes in pipe at LS toe good indicator that pipe is failing internally. Pipe should be examined internally for damage (video inspect).: As of 12/12/2013 the District discussed with farmer tenant what needed to be done, and the tenant informed the District that they would address the repairs.: As of 12/17/2013 District submitted letter to landowner explaining UCIP report details including photos of the pipe problems FIELD_STRUCT_DESC: 10-inch pipe through the levee 7.7-feet below the crown. Pump and slide gate on concrete pad on waterward slope. Siphon breaker in 24-inch CMP riser on LS slope. Concrete riser, power pole with panel box on landward toe. (ABO No. 11131-Latimer). Originally included in the O+M manual 1959. FS Date: 01/15/2014

Siphon breaker in 24-inch CMP riser on LS slope.

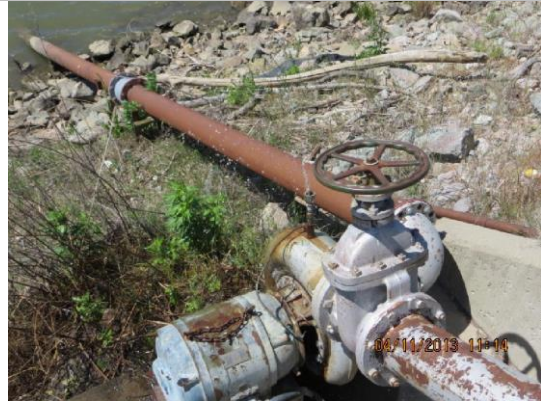
Photo 2 of 3 : UCIP\_FA\_2015\_2628.jpg

Inspector Comments: FS\_ID:26875  
 DS\_ID:22023  
 EP\_NO: 11131  
 FS\_HLM: 5.307  
 Repair Type: Non-Urgent  
 Crossing Status: Found  
 UCIP Comments: Based on District notes from January 15, 2014, pump discharge pipe has been repaired. Corrosion holes in pipe at LS toe good indicator that pipe is failing internally. Pipe should be examined internally for damage (video inspect).: As of 12/12/2013 the District discussed with farmer tenant what needed to be done, and the tenant informed the District that they would address the repairs.: As of 12/17/2013 District submitted letter to landowner explaining UCIP report details including photos of the pipe problems  
 FIELD\_STRUCT\_DESC: 10-inch pipe through the levee 7.7-feet below the crown. Pump and slide gate on concrete pad on waterward slope. Siphon breaker in 24-inch CMP riser on LS slope. Concrete riser, power pole with panel box on landward toe. (ABO No. 11131-Latimer). Originally included in the O+M manual 1959.

Pump and slide gate at Concrete pad on WS slope.

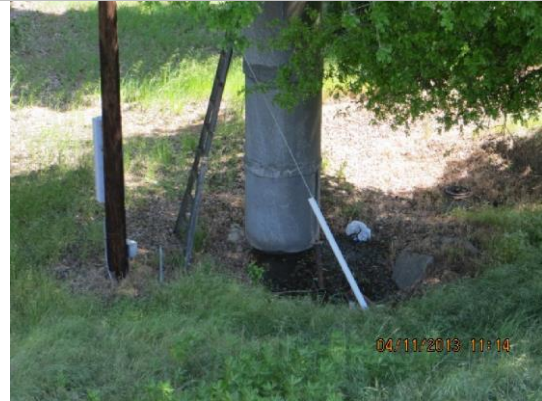
Photo 3 of 3 : UCIP\_FA\_2015\_2629.jpg

Concrete standpipe, JP and meter, and 4-inch steel pipe visible at LS toe.
